高压电池组装注意事项及故障排查

High voltage battery assembly precautions and troubleshooting

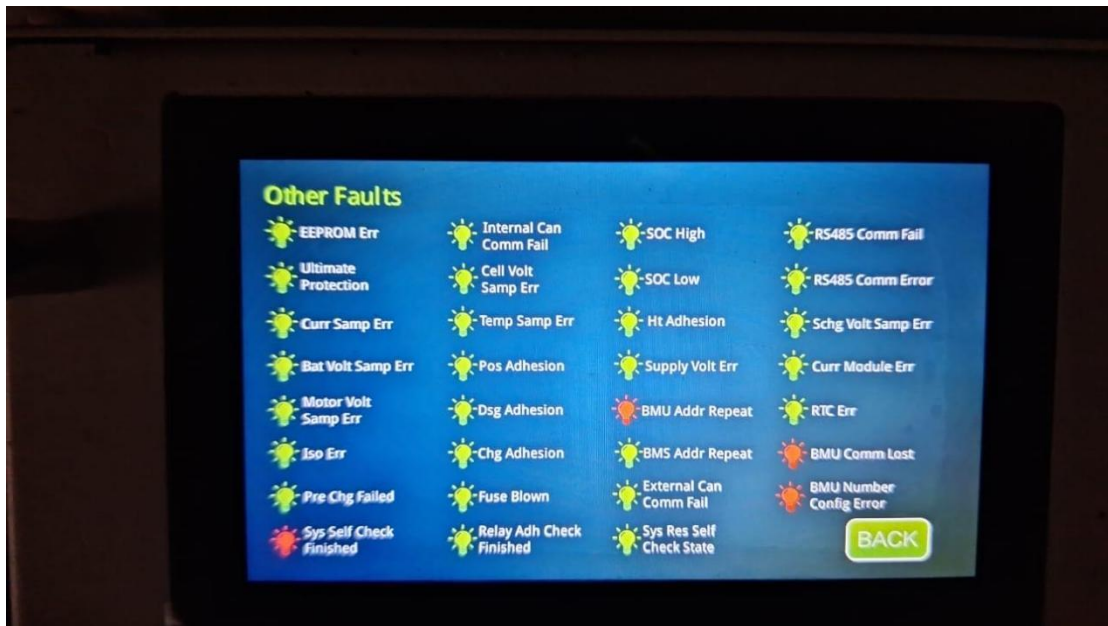
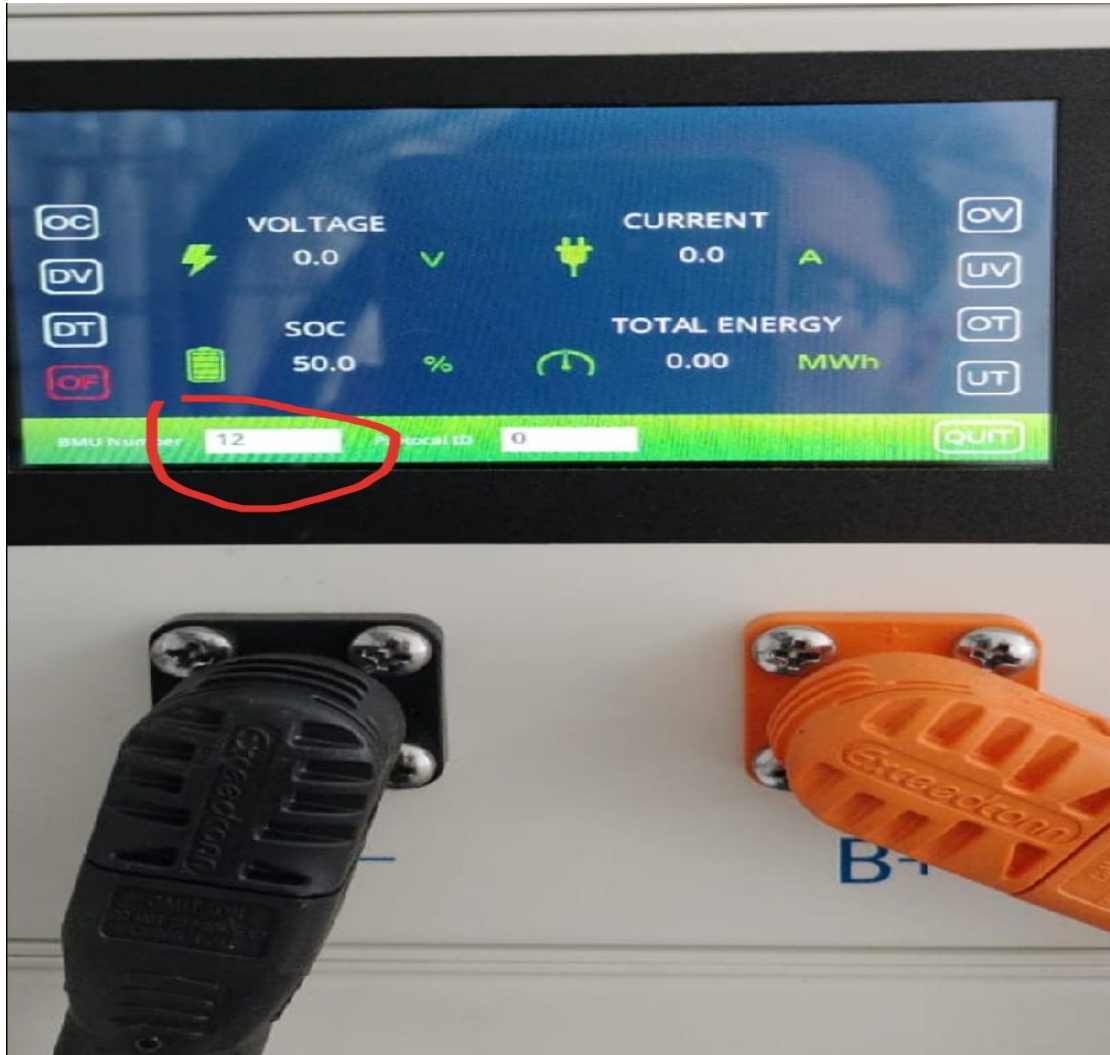
1. 首先确认一簇使用了几个电池：比如使用了 10 个，在 BMU Number 页面把 12 改成 10 并重启设备。如图

1. First verify the number of battery packs used in a cluster of batteries. For example, if 10 battery packs are used, change 12 to 10 on the BMU Number page and restart the device. As is shown in the following figure:

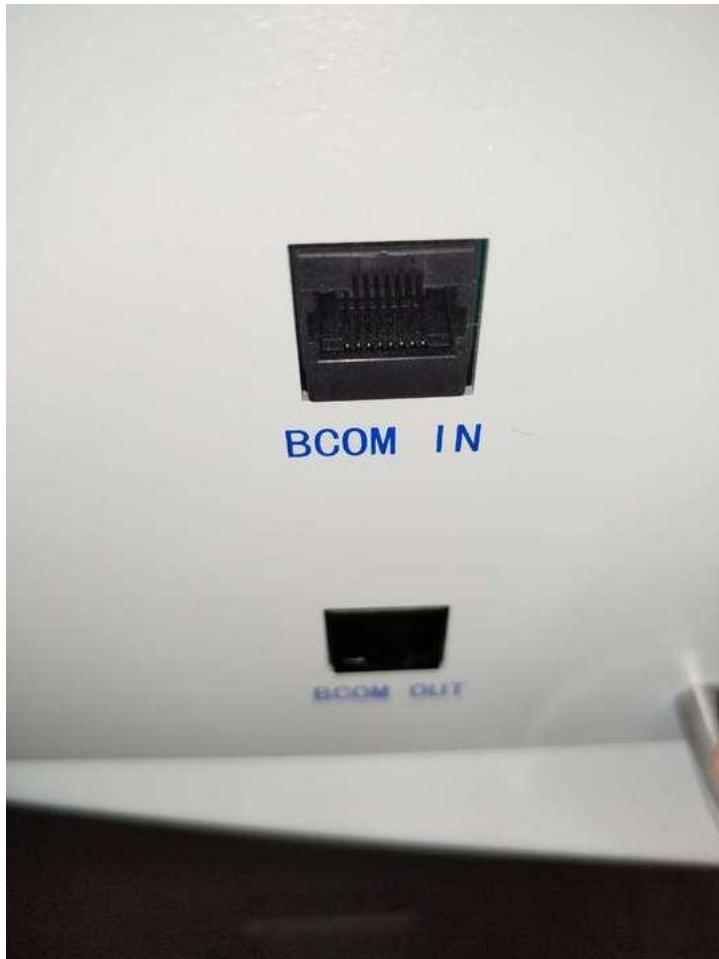
1) 该问题为电池与逆变器之间失去通讯引起;

The problem is caused by the loss of communication between the battery and the inverter.

2) 检查高压盒后端 PCS 口的 RJ45 端子, 检查是否有针脚凹陷、偏移、不回弹, 若存在问题, 尝试用镊子挑起凹陷针脚或摆正针脚, 若不回弹或凹陷问题严重, 更换高压盒或更换 RJ45 端子小板解决;

Check the RJ45 terminal of the PCS port at the back end of the high voltage box to see if the pins are dented, offset, or do not rebound. If there is a problem, please try to pick up the dented pins with tweezers or straighten the pins. If there is no rebound or serious sag problem, please replace the high pressure box or replace the RJ45 terminal plate to solve the problem.
